LAKE ROAD PLAZA ROOF CONDITION REPORT

EXECUTIVE SUMMARY
7780 & 7790 Lake Rd Orlando, FL 32821

7790 LAKE ROAD PLAZA BUILDING 1

7780 LAKE ROAD PLAZA BUILDING 2

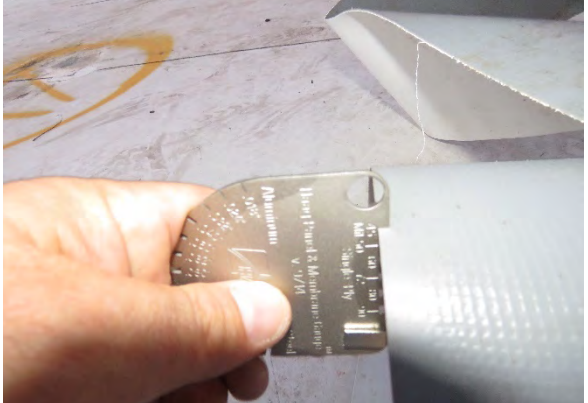
<p>The TPO membrane at wall was gaged at 45 mils.</p> <p>The contract drawings and specification require The TPO at walls and roof membrane be 60 mils. This was not in compliance.</p>

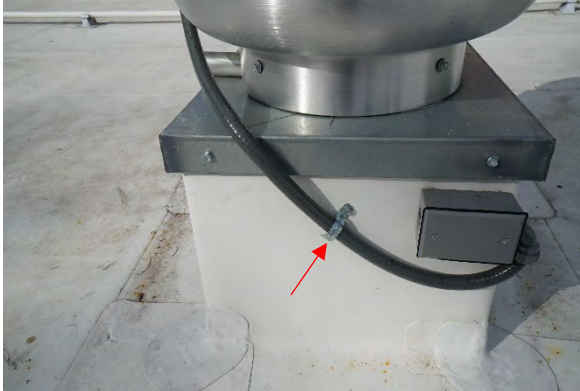
<p>Showing electrical clamp support attached with fasteners through the base flashing. This can void Firestone's warranty. Corrective action is required to eliminate penetration.</p>

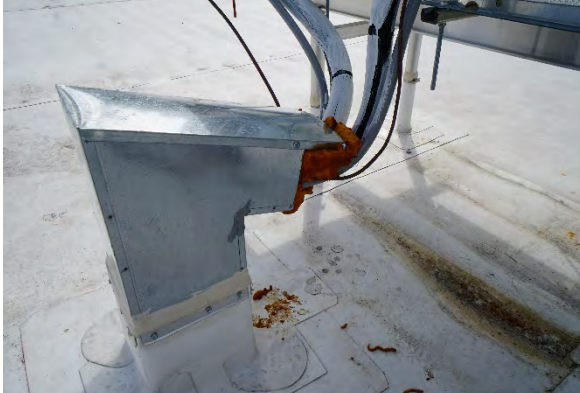
<p>The flex cable and copper tubing from the HVAC condenser units entering the vent hood shall have a drip line to prevent moisture entry into the roof assembly.</p>

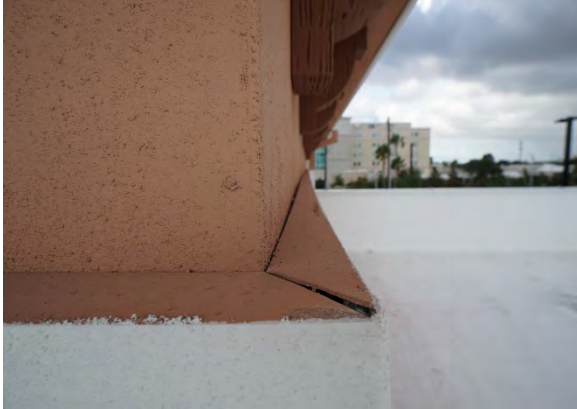
<p>All horizontal stucco accent bands should have a 1"-inch cove joint/cant applied at top of stucco band/ exterior wall attachment to prevent moisture entry into wall and roof assemblies.</p>

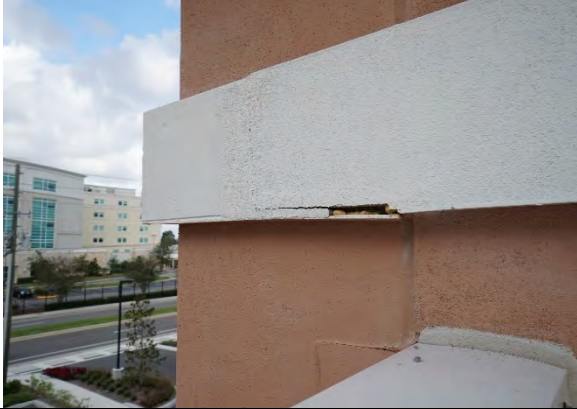
<p>The stucco accent band should have had an expansion joint installed to prevent cracking.</p>

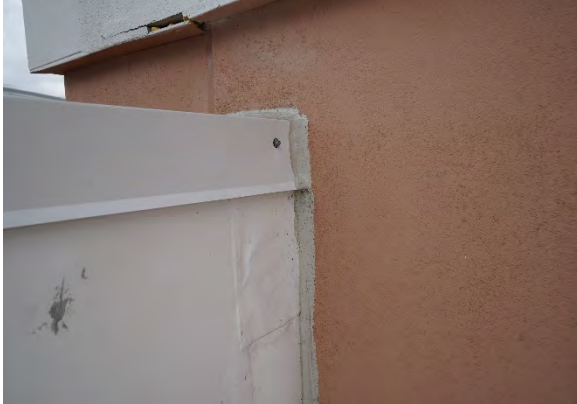
<p>Improper termination of metal coping cap at parapet wall termination. Metal counter flashing should be installed to prevent moisture intrusion.</p>

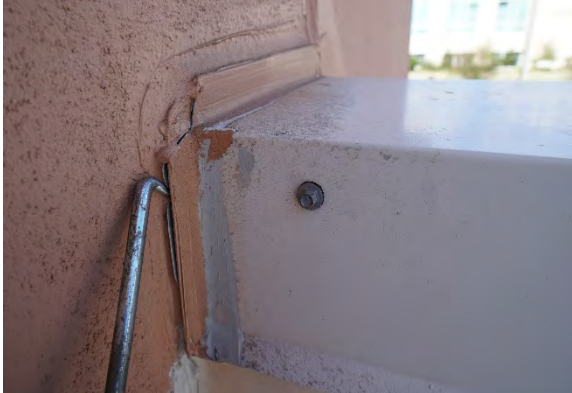
<p>Improper termination of metal coping cap at parapet wall termination. Metal counter flashing should be installed over the top of the coping flanges. Expansion and contraction will cause voids potentially allowing moisture to enter the parapet wall and roof assemblies.</p>

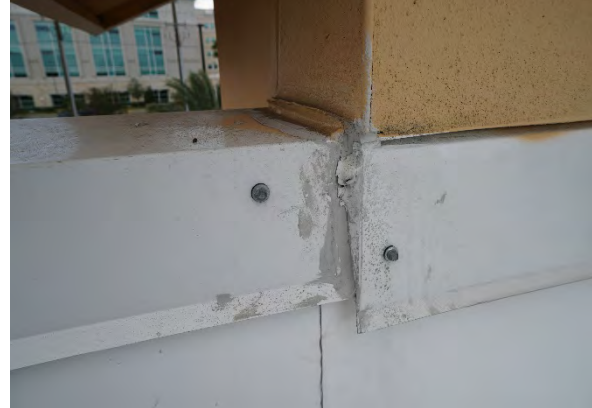
<p>Improper termination of metal coping cap at parapet wall termination. Metal counter flashing should be installed over the top of the coping flanges. Expansion and contraction will cause voids potentially allowing moisture to enter the parapet wall and roof assemblies.</p>
 	<p>Showing void at coping cap parapet wall termination.</p>

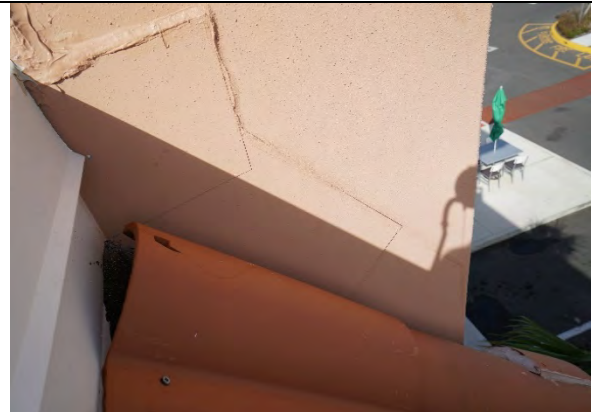
<p>Roof-to-wall flashing at mansard tile roof tilt wall connection should be counter flashed with a surface mounted flashing. (Typical), at roof-to-wall flashing for tile roof systems.</p>

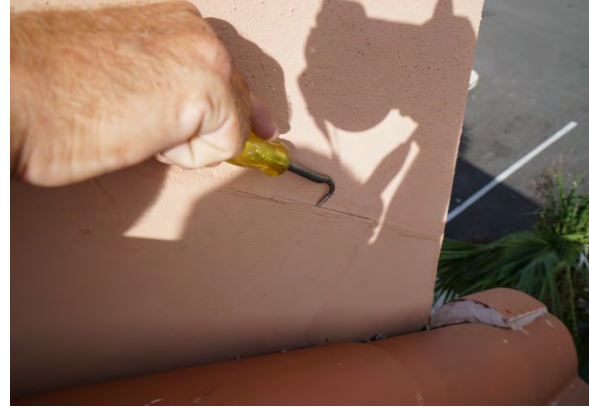
<p>Roof-to-wall flashing at mansard tile roof tilt wall connection should be counter flashed with a surface mounted flashing. (Typical), at roof-to-wall flashing for tile roof systems.</p> <p>The photograph shows the flashing separating from wall. This condition will allow water to leak into lower roof assembly.</p>

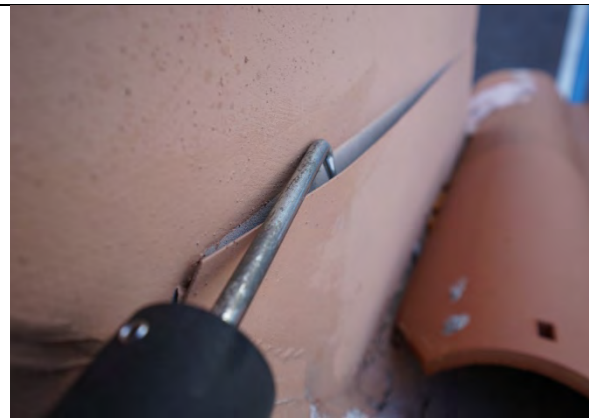
<p>Roof-to-wall flashing at mansard tile roof tilt wall connection should be counter flashed with a surface mounted flashing. (Typical), at roof-to-wall flashing for tile roof systems.</p> <p>The photograph shows the flashing separating from wall. This condition will allow water to leak into lower roof assembly.</p>

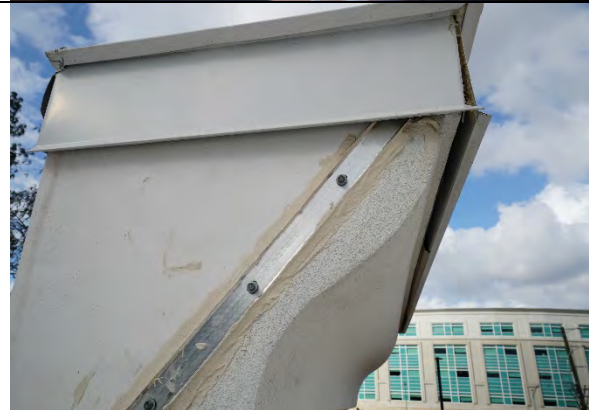
<p>The perimeter edge metal at various locations was not hooked properly to the fascia metal. Also, observed, many locations did not have any continuous cleats installed as required per specifications and contract.</p>

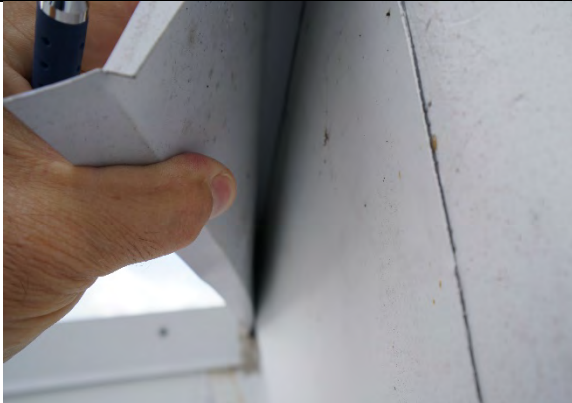
<p>The perimeter edge metal at various locations was not hooked properly to the fascia metal. Also, observed, many locations did not have any continuous cleats installed as required per specifications and contract.</p>

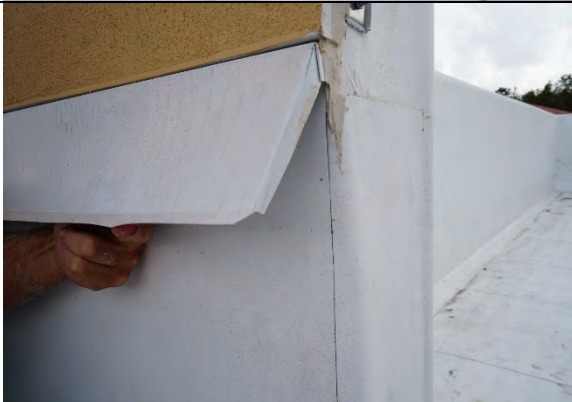
<p>The perimeter edge metal at various locations was not hooked properly to the fascia metal. Also, observed, many locations did not have any continuous cleats installed as required per specifications and contract.</p>

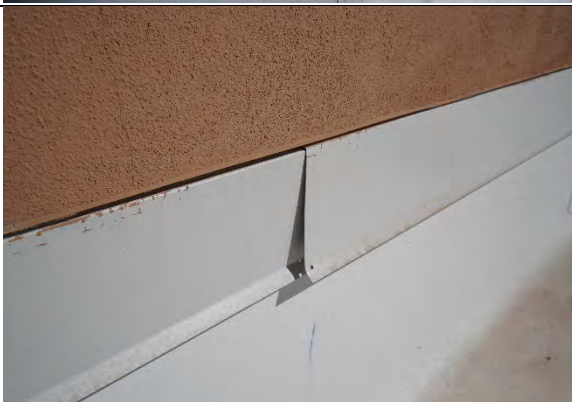
<p>Metal counter flashing at exterior stucco wall/roof connection did not have clips or fasteners to prevent against high wind events.</p>

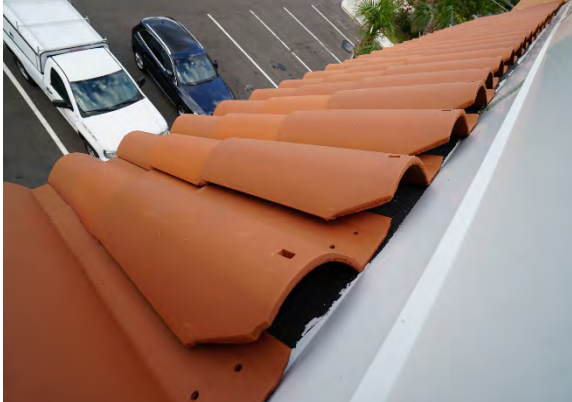
<p>Hazardous Condition</p> <p>The contract requires that the clay roof tiles be attached to roof with one fastener along with a large paddy of foam adhesive under each tile. At, many locations this was not complied to. This condition is a hazard and requires immediate correction to prevent severe injury or death.</p>

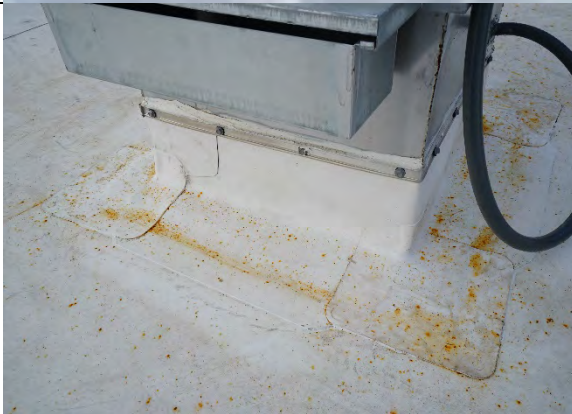
<p>Per manufacturer's requirements and technical specifications, Firestone does not warrant products incorporated or utilized in the installation that were not furnished by Firestone. This was not complied to. GAF TPO EverGuard corner flashing was installed at curbs and other penetrations. This could void the Manufacturer's warranty.</p>

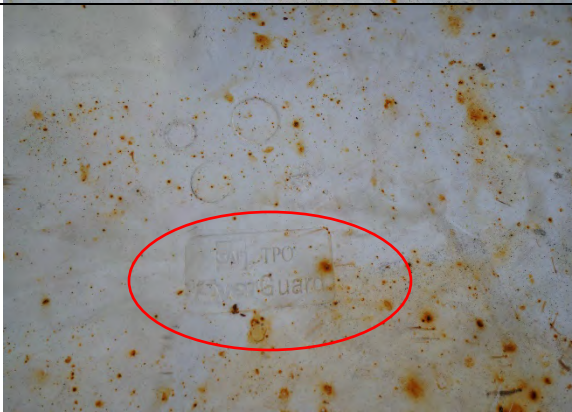
<p>Per manufacturer's requirements and technical specifications, Firestone does not warrant products incorporated or utilized in the installation that were not furnished by Firestone. This was not complied to. GAF TPO EverGuard corner flashing was installed at curbs and other penetrations. This could void the Manufacturer's warranty.</p>

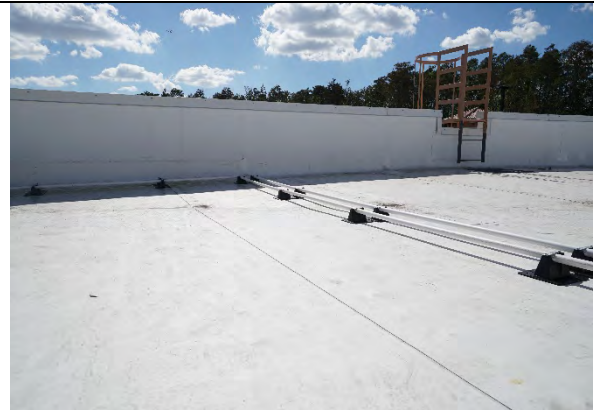
<p>Showing condensate pipes with incorrect slope. This condition can cause moisture not to drain properly clogging the pipes.</p>

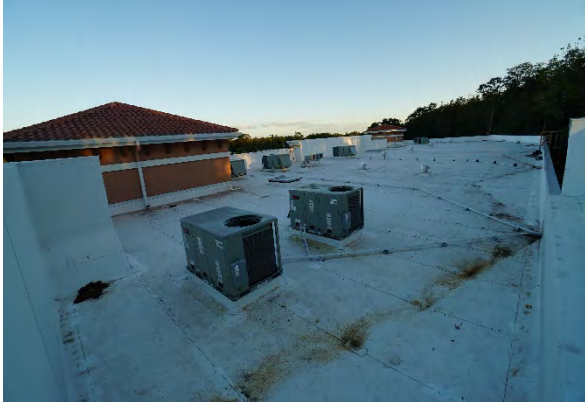
<p>Showing aerial photograph of roof tapered system. Bldg. (2)</p> <p>The taper crickets between scuppers according to the contract drawings should have a 45° taper. This was not complied to during application.</p>

<p>Showing roof deflection at parapet wall/roof connection. This condition allows water to pond. Infrared thermography and capacitance moisture scanner showed elevated levels of moisture. This location is above Quest Diagnostics where active leaks were detected.</p>

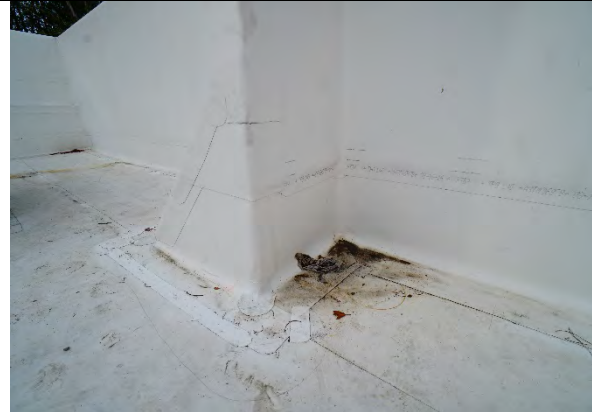
<p>Missing tapered cricket. Ponding water was observed. Recommend correction by adding tapered cricket to allow water to drain as designed.</p>

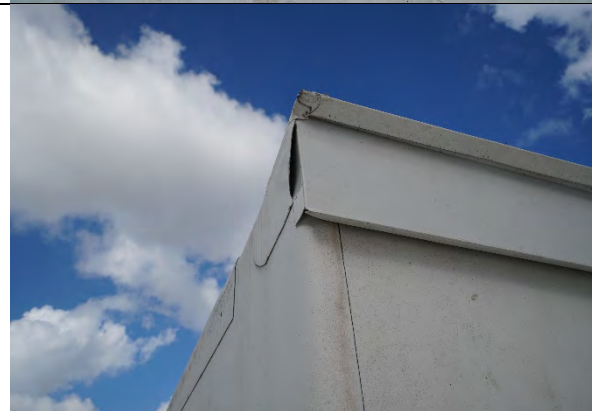
<p>Open lap seam at top corner of parapet wall.</p>

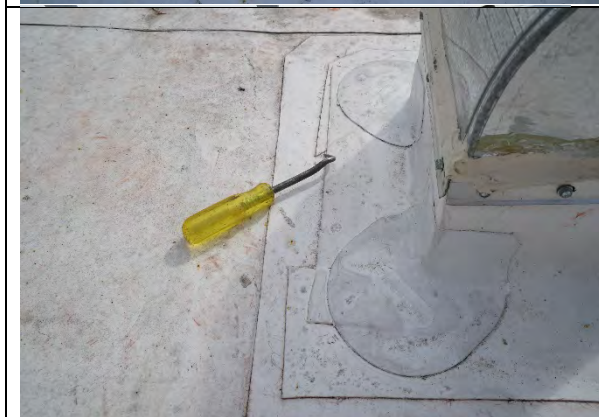
Missing T-patch at base of goose neck per manufacturers requirements.

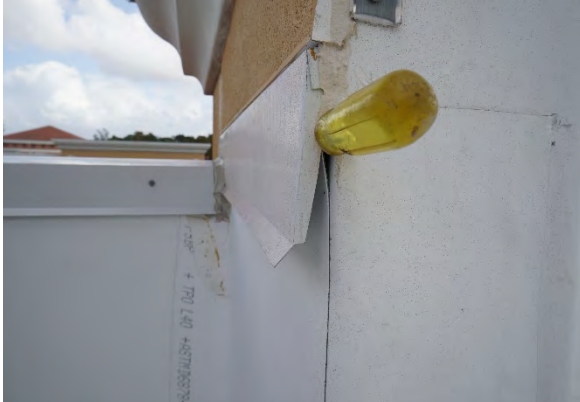
<p>Showing open lap seam underneath counter flashing.</p>

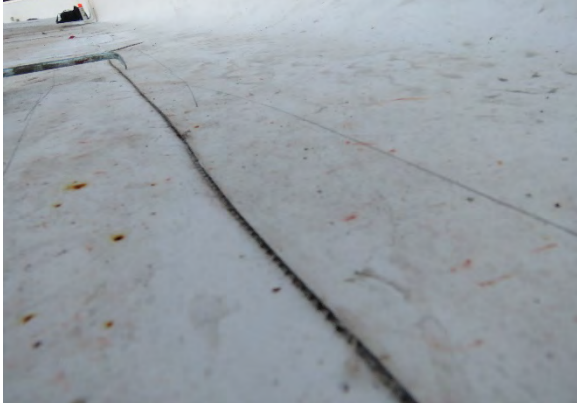
<p>Recommend adding edge cut sealant per manufacturer's requirements. This condition was observed at many locations and needs to be sealed everywhere the membrane has a cut edge.</p>

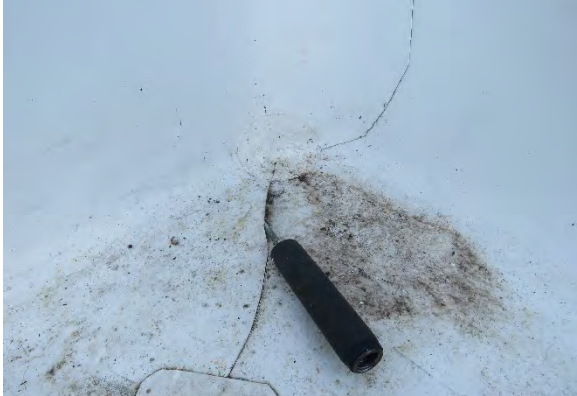
<p>Open laps seams in corner wall/roof connection at right rear elevation for building (2) above Quest Diagnostics.</p>

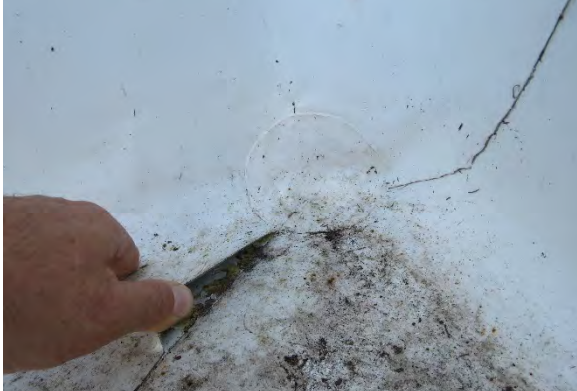
<p>Open laps seams in corner wall/roof connection at right rear elevation for building (2) above Quest Diagnostics.</p> <p>This most likely appears to be the location of leak above Quest Diagnostics.</p>

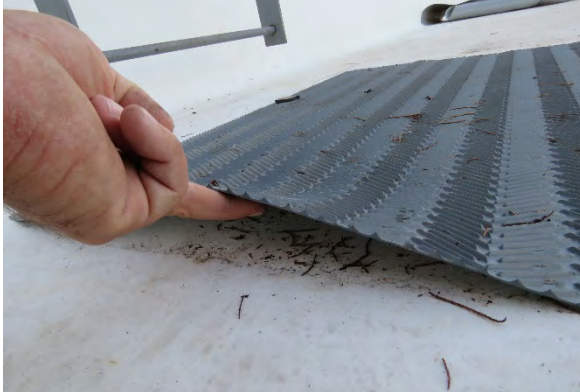
<p>Walk pads not correctly welded per manufacturer's requirements.</p>

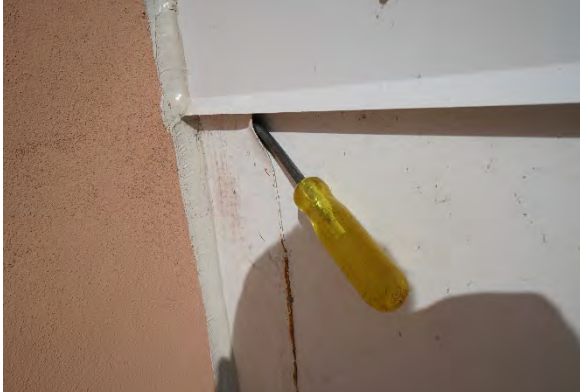
<p>Showing open lap seam at roof tower exterior wall/parapet wall connection. This condition can potentially allow moisture entry into both the wall and roof assemblies</p>

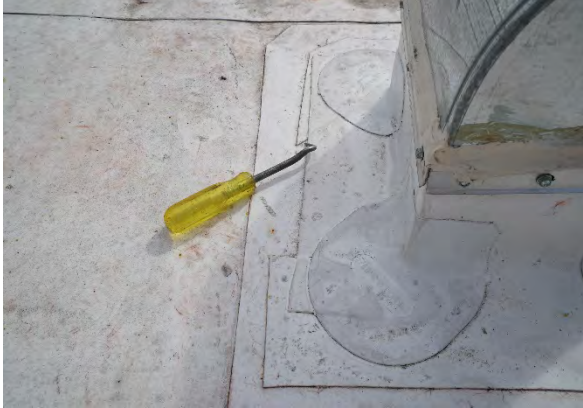
<p>Missing T-patches at base of vent hood and other location were observed. Manufacturer requires this.</p>

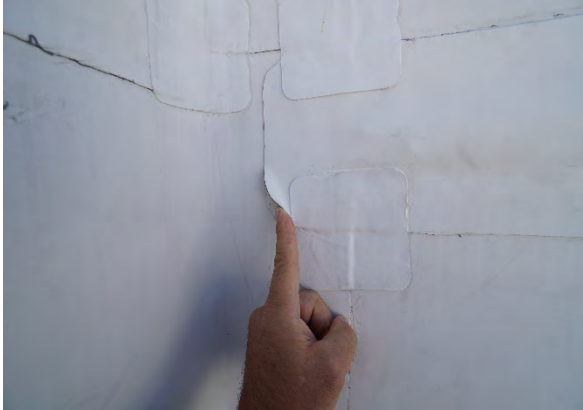
<p>Open lap seams at inside corner of parapet wall.</p>

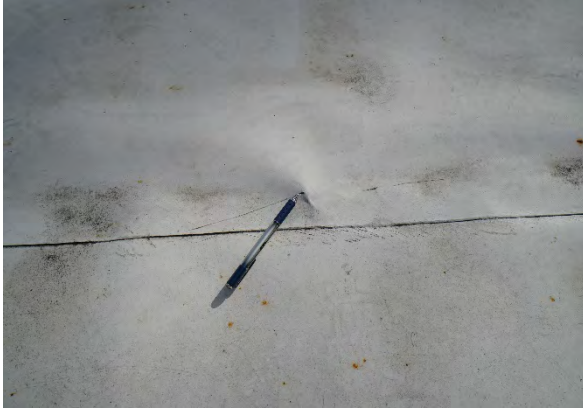
<p>Showing a puncture to the surface roof membrane. Corrective action required to prevent water leaking beneath membrane and into the roof assembly.</p>

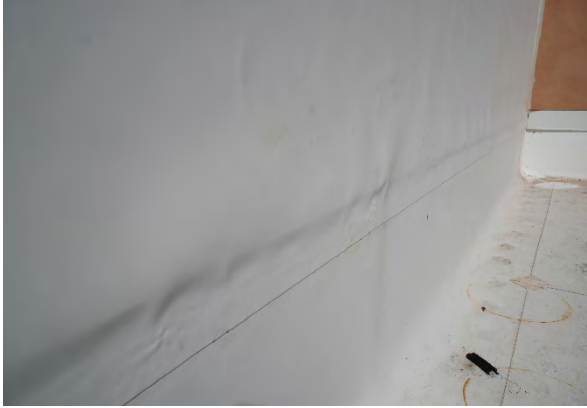
<p>Many sections of the large and small parapet walls were not fully adhered with bonding adhesive as required by specification.</p>
 	<p>Many sections of the large and small parapet walls were not fully adhered with bonding adhesive as required by specification.</p>

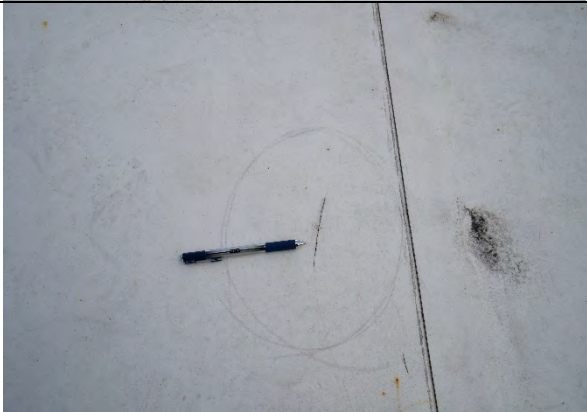
<p>Single-ply membrane surface damage founded at various locations. The slice did not appear to penetrate the membrane, but further evaluation required.</p>

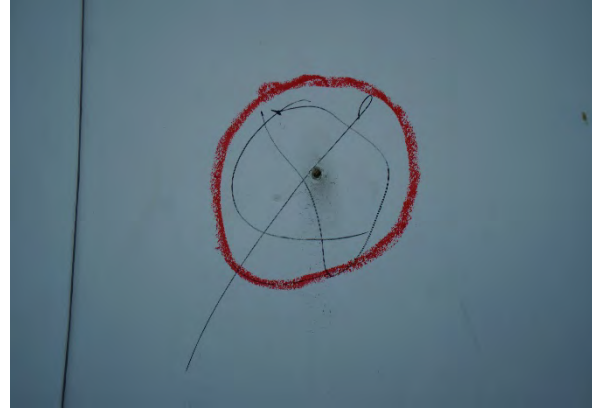
<p>Showing a puncture to the surface wall membrane. Corrective action required to prevent water leaking beneath membrane and into the wall/roof assemblies.</p>

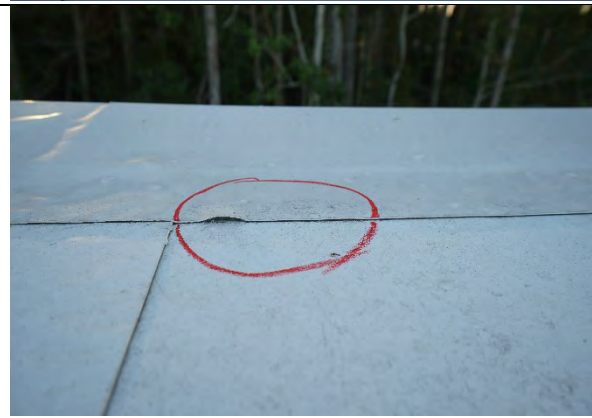
<p>Showing open lap seam at top of larger parapet wall.</p>

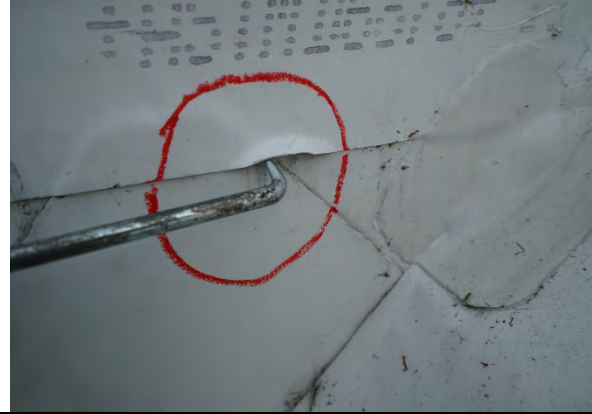
<p>Open lap seams at parapet wall.</p>
 	<p>Open lap seams at scuppers. This scupper was located above Quest Diagnostic where leaks were reported.</p> <p>The contractor made several attempts to repair leak. Infrared thermography and a capacitance moisture scans identified elevated moisture levels. A visible inspection was made at the interior sealing where staining was visible. Recommend further evaluation.</p>

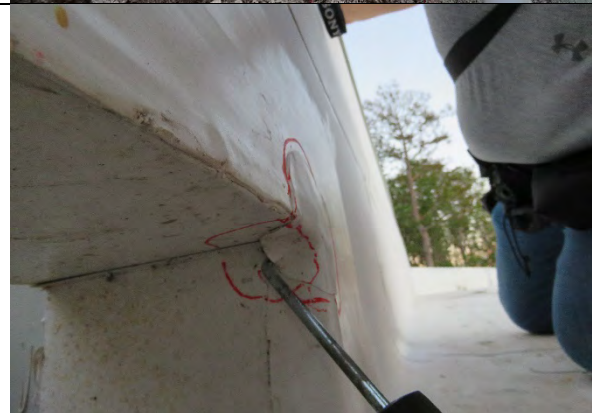
<p>Open lap seams at scuppers. This scupper was located above Quest Diagnostic where leaks were reported.</p> <p>The contractor made several attempts to repair leak. Infrared thermography and a capacitance moisture scans identified elevated moisture levels. A visible inspection was made at the interior sealing where staining was visible. Recommend further evaluation.</p>

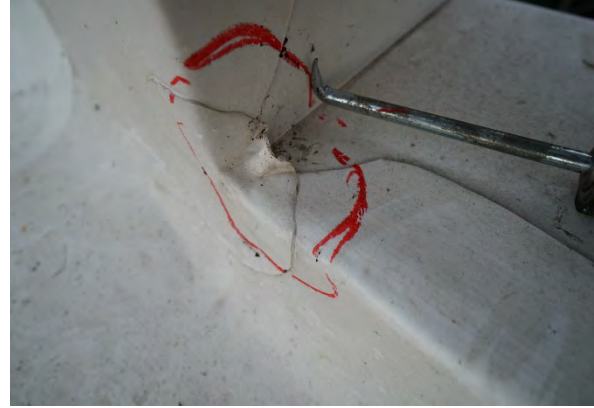
<p>Open lap seams at scuppers. This scupper was located above Quest Diagnostic where leaks were reported.</p> <p>The contractor made several attempts to repair leak. Infrared thermography and a capacitance moisture scans identified elevated moisture levels. A visible inspection was made at the interior sealing where staining was visible. Recommend further evaluation.</p>

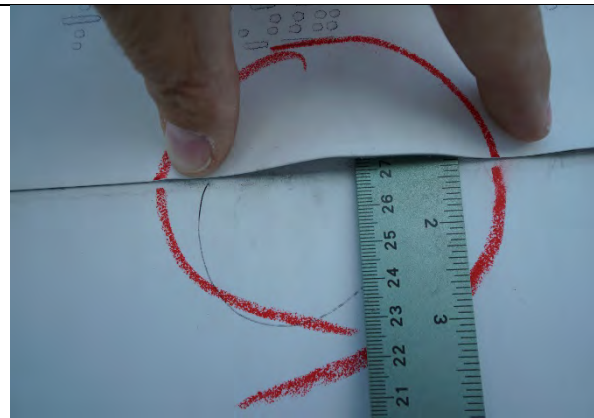
<p>Open lap seams at parapet wall.</p> <p>At many locations found welds not consistent with the 1.5"-inch weld per manufacturer's specifications.</p>

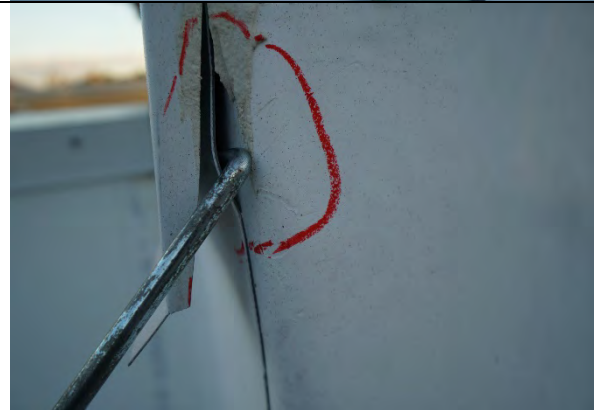
<p>Open lap seams were found along parapet walls, perimeters of scuppers, on top of parapet walls and roof membrane,</p>

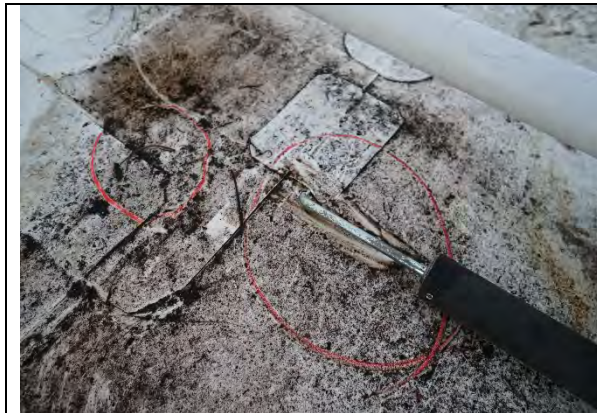
Open laps seams observed at roof membrane close to parapet wall.

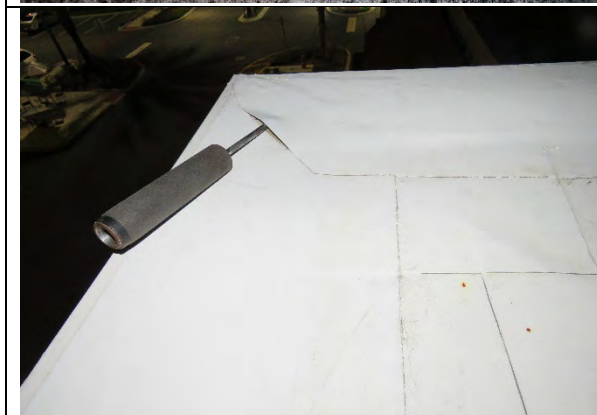
Open laps at top of parapet wall. This condition will allow moisture to leak beneath membrane and potentially leak into the roof assembly.

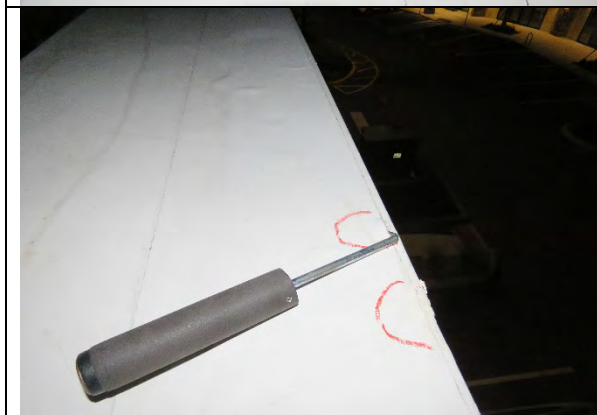
Open laps at top of parapet wall. This condition will allow moisture to leak beneath membrane and potentially leak into the roof assembly.

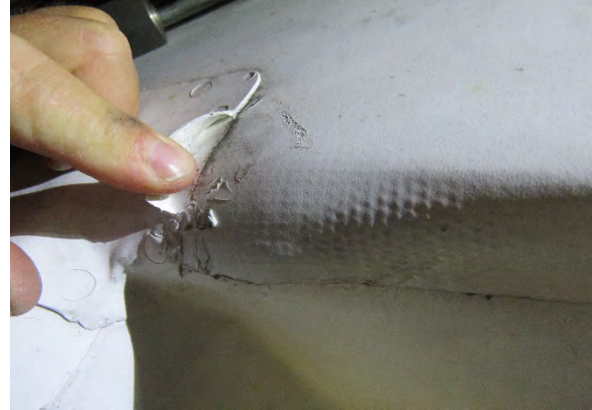
<p>Showing open lap seam at top inside corner of parapet wall.</p>

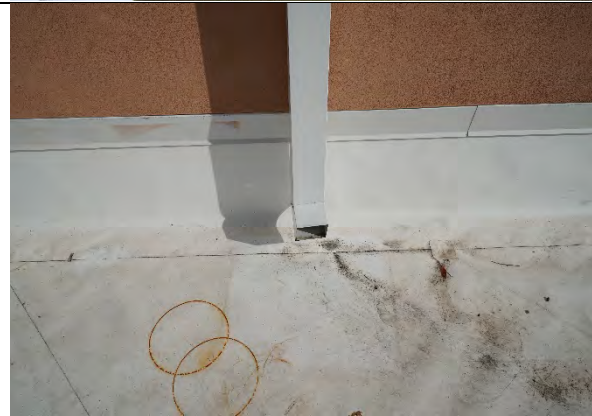
<p>Missing splash pads at bottom of downspouts. This condition will accelerate the deterioration of the membrane.</p>

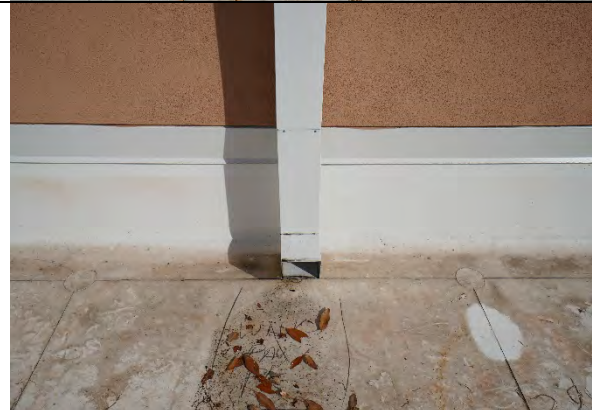
<p>Missing splash pads at bottom of downspouts. This condition will accelerate the deterioration of the membrane.</p>

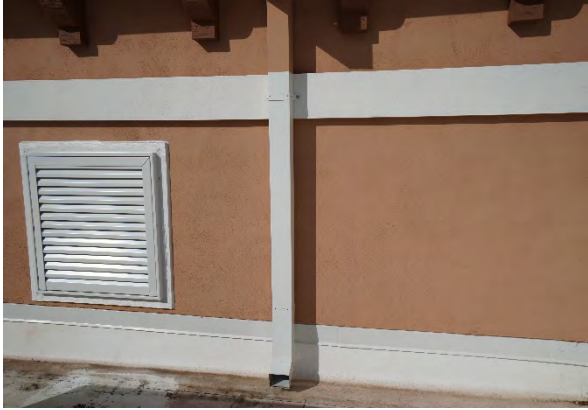
<p>Downspouts need additional brackets to be properly secured.</p>

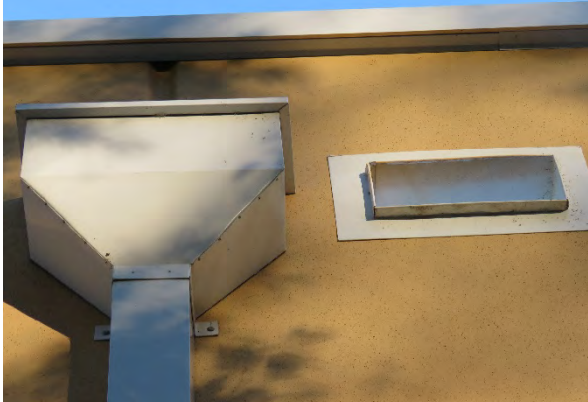
<p>The scupper face plate should be fastened to exterior wall and sealed around perimeter.</p> <p>The collector heads should also be attached with appropriate fasteners and sealed around perimeter.</p>

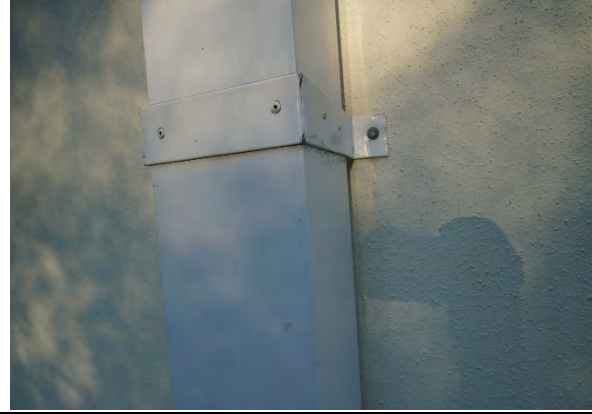
<p>The brackets (straps) should be properly secured to the walls. The Brackets should be hidden.</p>
 	<p>Condensate pipes shall be properly supported across the roof. All supports should be fully adhered to the roof system for protection from high wind events.</p>
 	<p>Plans, specifications and contract require coping metal to be secured 12"-inch o.c. This was not in compliance.</p>

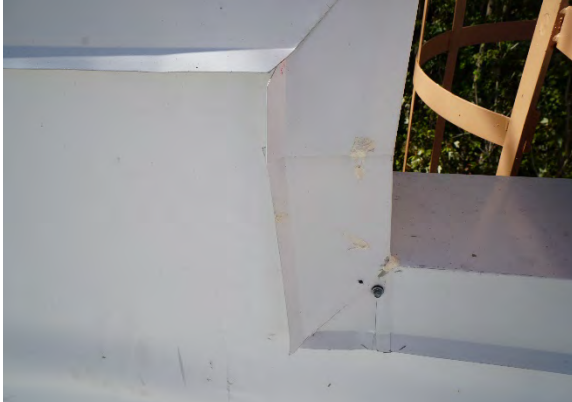
<p>Showing screw hole in metal flashing. Recommend sealing to prevent moisture entry.</p>

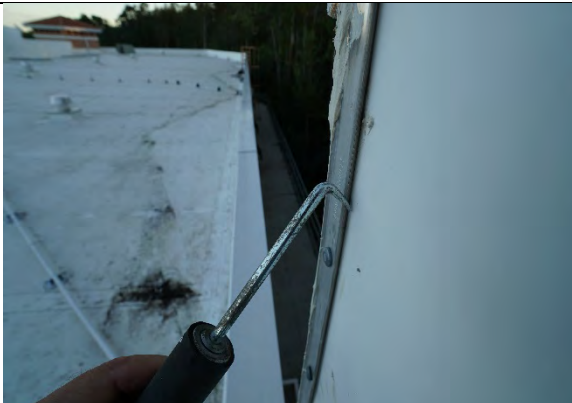
<p>Termination should be sealed with appropriate sealant per drawings.</p>

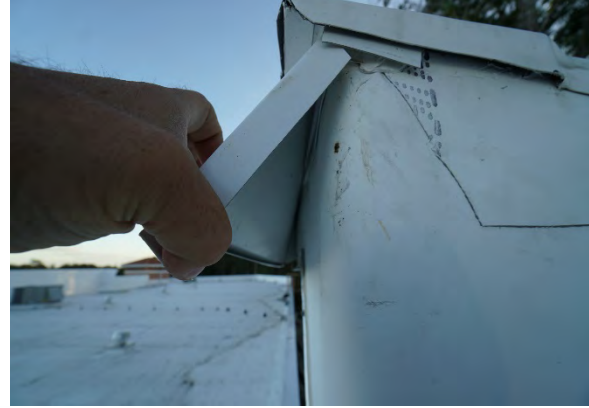
<p>The perimeter edge metal at various locations was not hooked properly to the fascia metal. Also, observed, many locations did not have any continuous cleats installed as required per specifications and contract.</p>

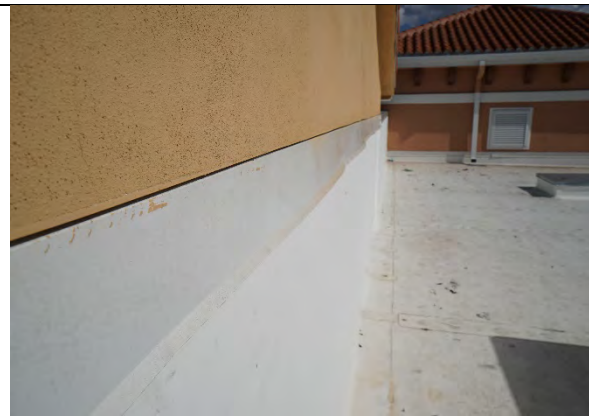
<p>Metal counter flashing at exterior stucco wall/roof connection did not have clips or fasteners to prevent against high wind events.</p>

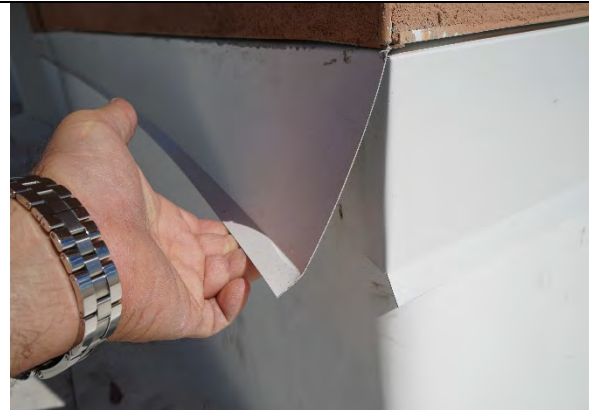
<p>Metal counter flashing at exterior stucco wall/roof connection did not have clips or fasteners to prevent against high wind events.</p>

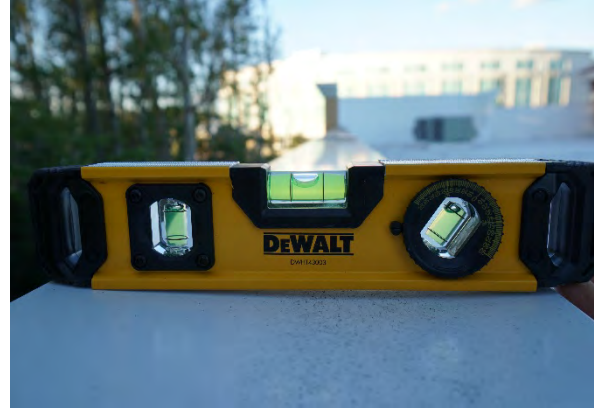
<p>Metal coping cap not in compliance with specifications and contract. Coping was not sloped 1/2"-inch per foot towards the inside of the roof.</p>

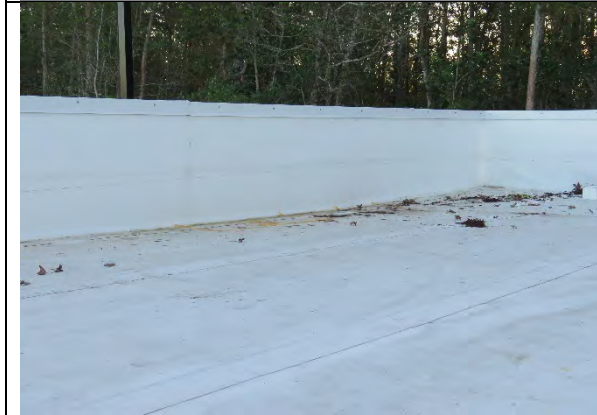
Showing roof deflection at parapet wall/roof connection. This condition allows water to pond. Infrared thermography and capacitance moisture scanner showed elevated levels of moisture. This location is above Quest Diagnostics where active leaks were detected.

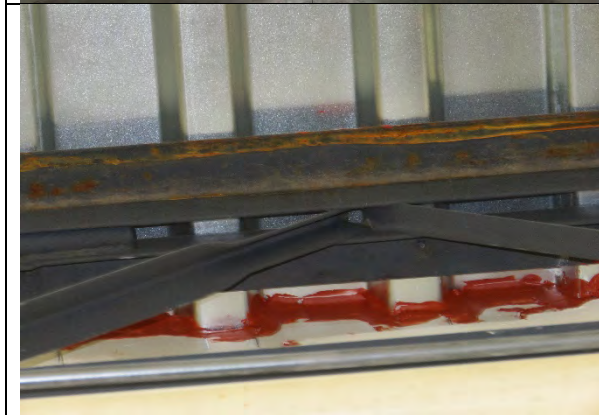
Showing rust on steel trusses under the metal roof deck indicates roof leaks.

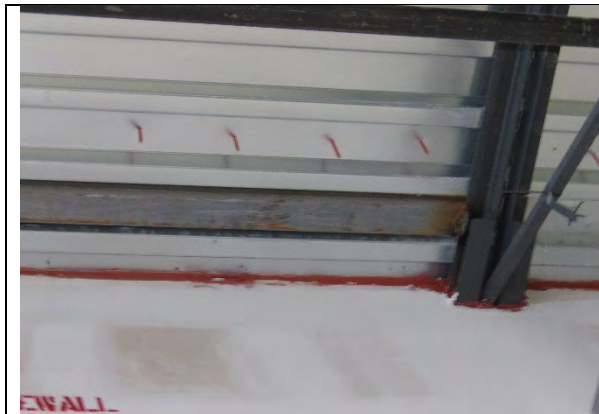
Showing rust on steel trusses under the metal roof deck indicates roof leaks.

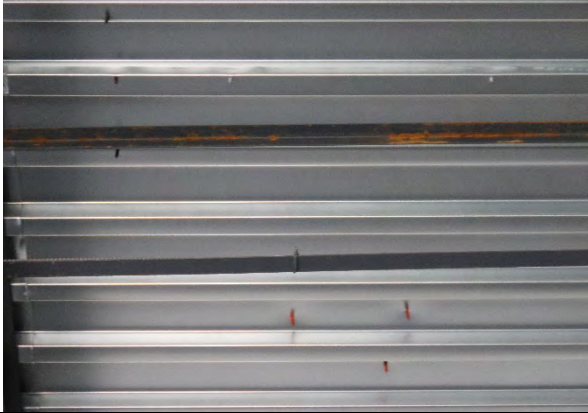
<p>Showing rust on steel trusses under the metal roof deck indicates roof leaks.</p>
