LAKE ROAD PLAZA ROOF CONDITION REPORT

EXECUTIVE SUMMARY
7780 & 7790 Lake Rd Orlando, FL 32821

7790 LAKE ROAD PLAZA BUILDING 1

7780 LAKE ROAD PLAZA BUILDING 2

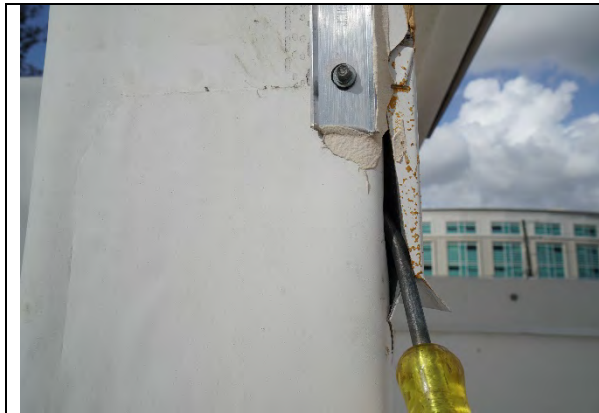
Showing open lap seam underneath counterflashing.

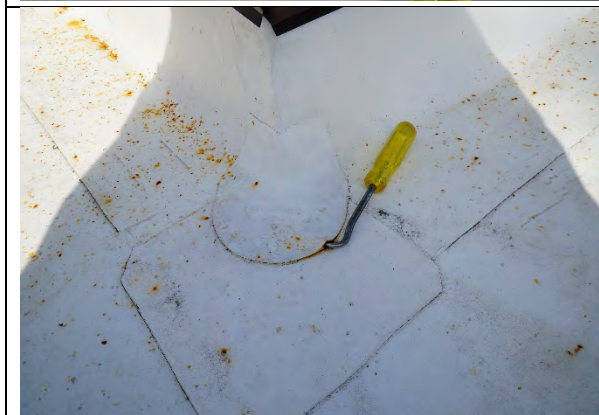
Showing open lap seam at outside corner patch at base of goose neck vent.

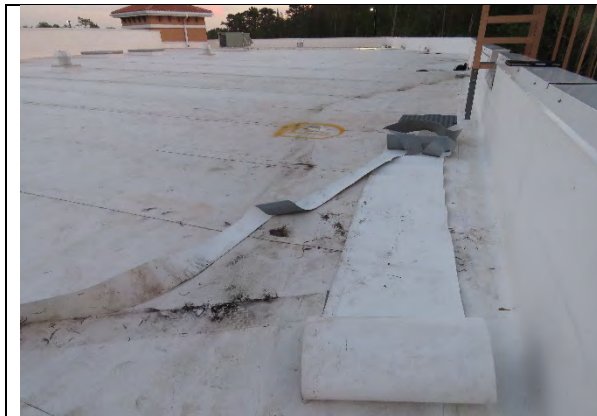
Showing left over TPO membrane left of roof.

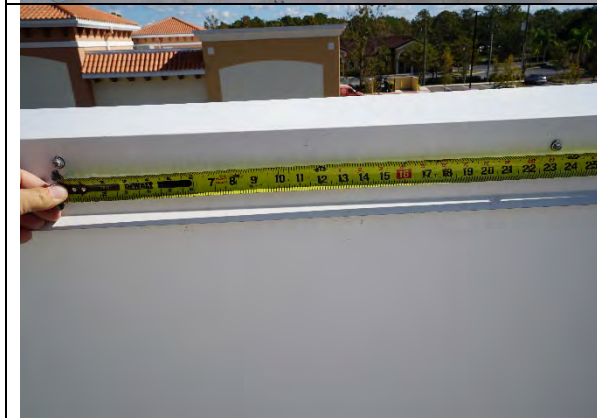
Plans, specifications and contract require coping metal to be secured 12"-inch o.c. This was not in compliance.

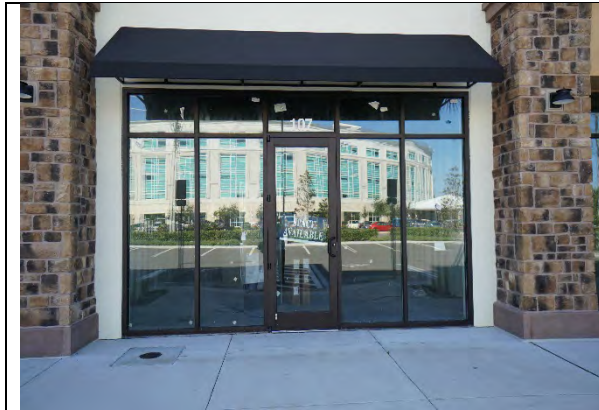
General view of exterior unit #107

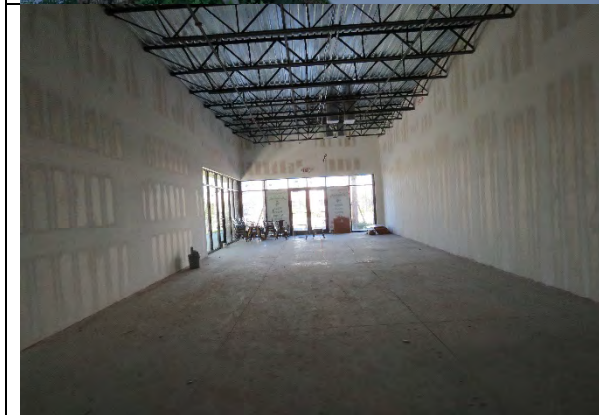
General view of interior unit # 108
