LAKE ROAD PLAZA ROOF CONDITION REPORT

EXECUTIVE SUMMARY
7780 & 7790 Lake Rd Orlando, FL 32821

7790 LAKE ROAD PLAZA BUILDING 1

7780 LAKE ROAD PLAZA BUILDING 2

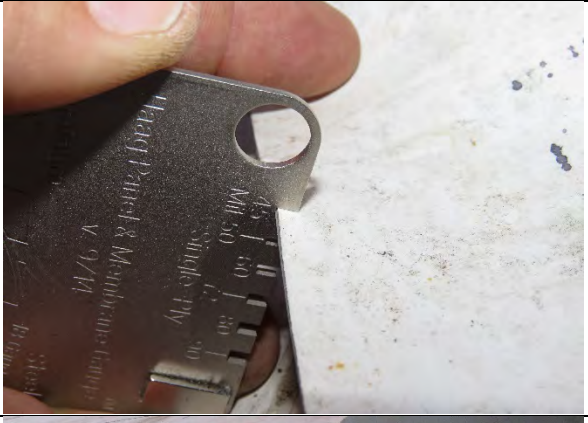
<p>The TPO membrane at wall was gaged at 45 mils.</p> <p>The contract drawings and specification require The TPO at walls and roof membrane be 60 mils. This was not in compliance.</p>

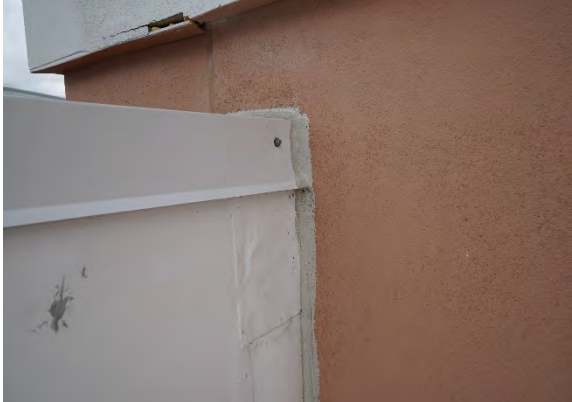
<p>Showing coping cap termination at tilt wall.</p>

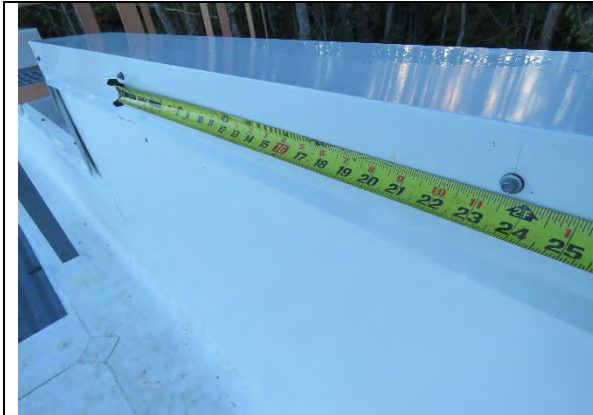
Plans, specifications and contract require coping metal to be secured 12"-inch o.c. This was not in compliance.

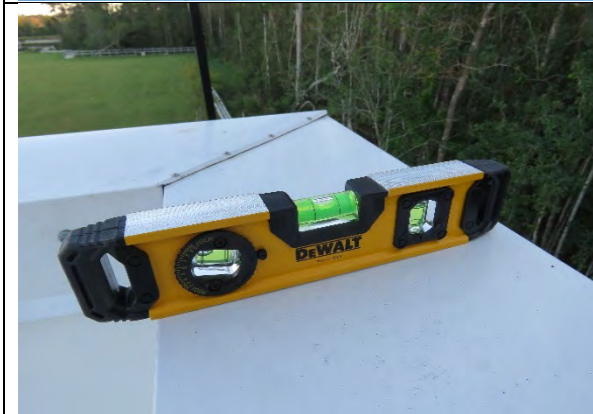
Metal coping cap not in compliance with specifications and contract. Coping was not sloped $\frac{1}{2}$ "-inch per foot towards the inside of the roof.

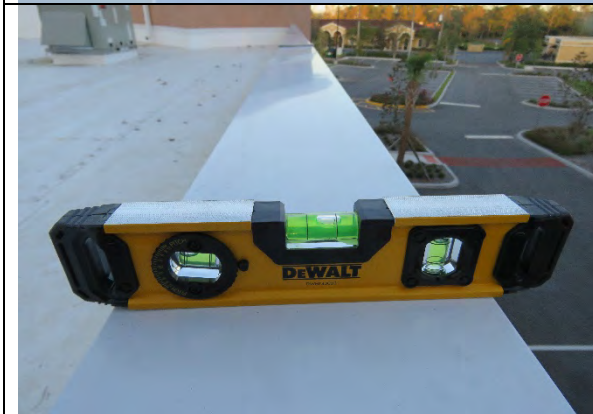
Metal coping cap not in compliance with specifications and contract. Coping was not sloped $\frac{1}{2}$ "-inch per foot towards the inside of the roof.

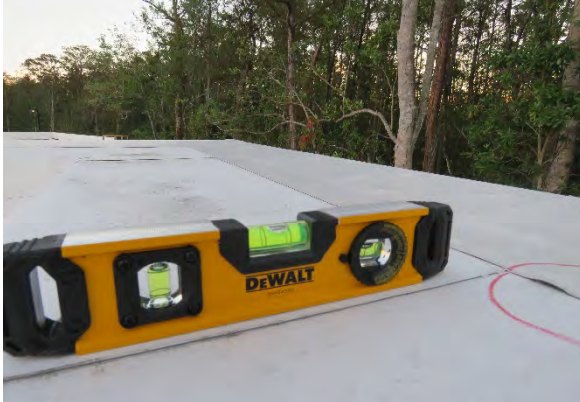
<p>Parapet cap at tilt wall was not sloped ½"-inch per foot towards the inside of the roof per specifications.</p>

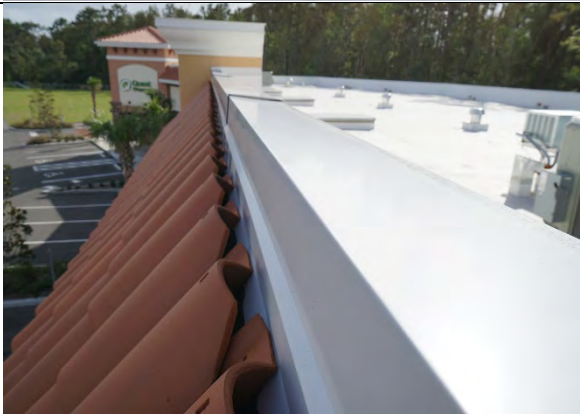
<p>Head wall flashing at tile mansard/parapet wall connection was not properly sealed across the top of roof tiles. The contract calls for mortar to be applied at a minimum. A more positive feature would be to install lead flashing or Wakaflex flashing over the roof tiles.</p>

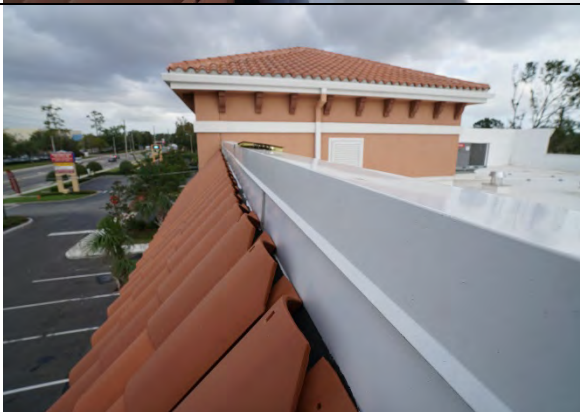
<p>Head wall flashing at tile mansard/parapet wall connection was not properly sealed across the top of roof tiles. The contract calls for mortar to be applied at a minimum. A more positive feature would be to install lead flashing or Wakaflex flashing over the roof tiles.</p>

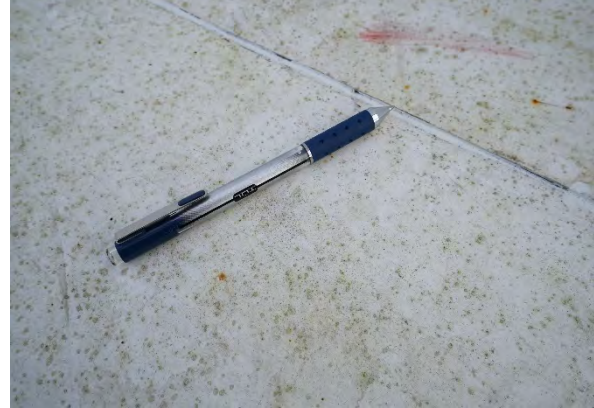
<p>Showing a TPO membrane cut edged sealed per manufacturer's requirements.</p>

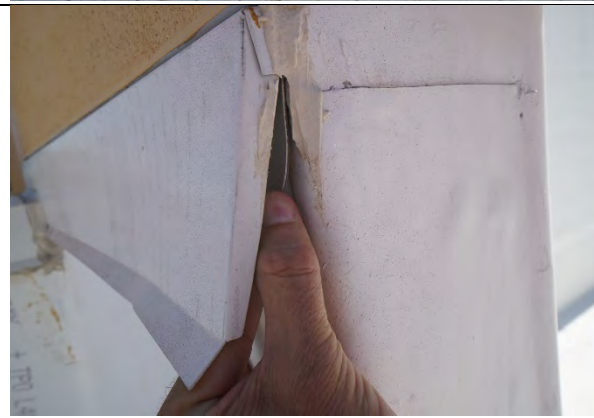
<p>Showing open lap seam underneath counterflashing.</p>

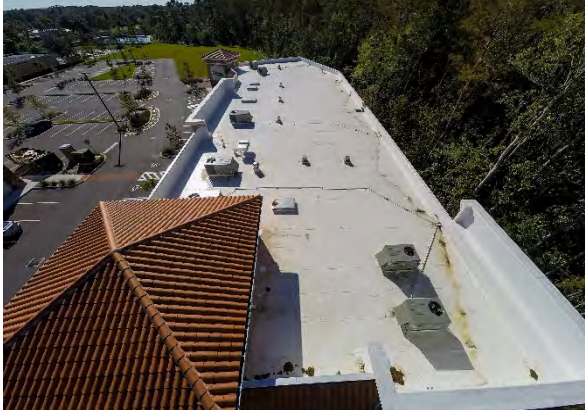
<p>Showing aerial photograph of roof tapered system. Bldg. (2)</p> <p>The taper crickets between scuppers according to the contract drawings should have a 45° taper. This was not complied to during application.</p>

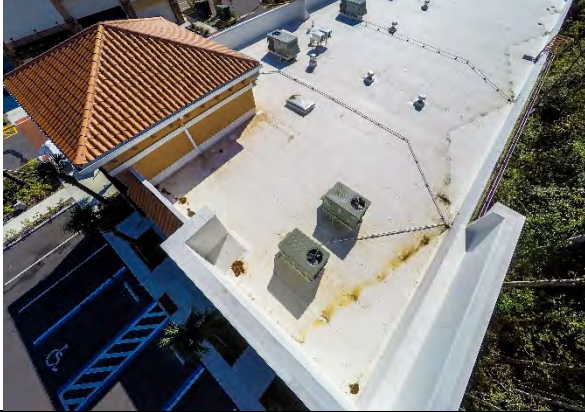
<p>Showing aerial photograph of roof tapered system. Bldg. (2)</p> <p>The taper crickets between scuppers according to the contract drawings should have a 45° taper. This was not complied to during application.</p>

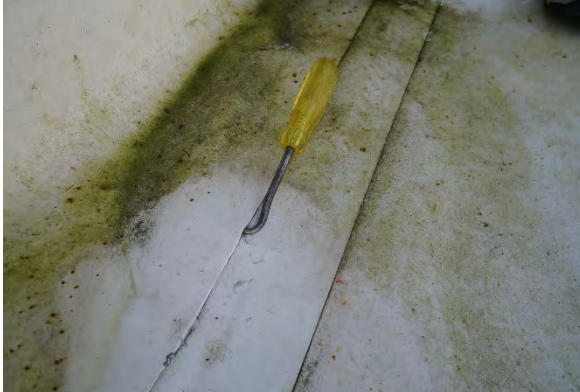
<p>Showing open lap seams in roof membrane at base of RTU's</p>

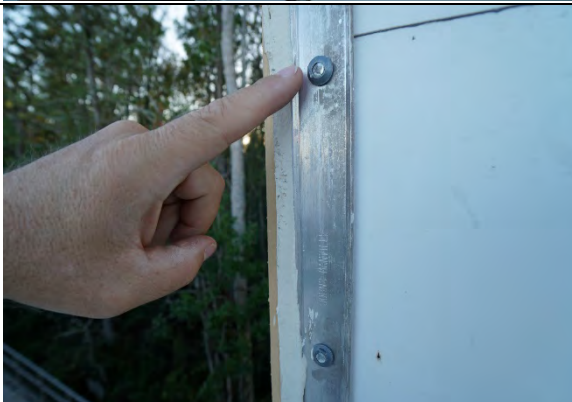
<p>Masonry anchors through termination bar should have appropriate sealant or neoprene washers.</p>

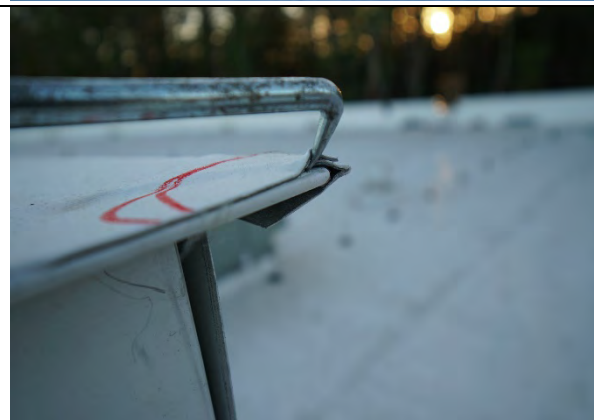
<p>Showing open seam at edge flashing at parapet wall</p>

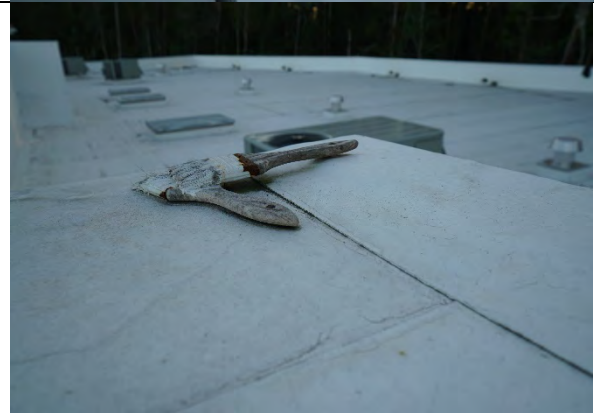
<p>Showing paint brushes stuck to membrane at top of parapet wall.</p>

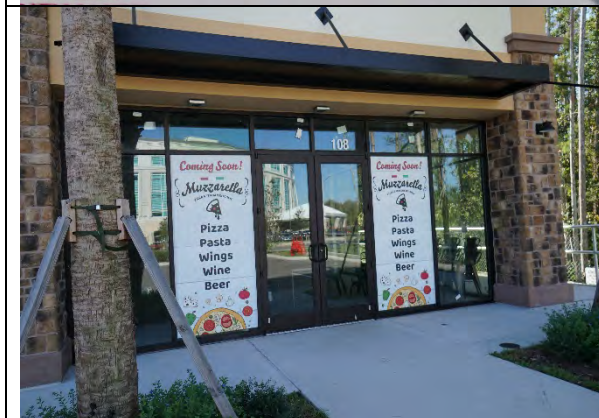
General view of unit # 108
